POINT AU FER ISLAND HYDROLOGIC RESTORATION (TE-22)

TE-22-MSPR-0498-1

PROGRESS REPORT No. 1

July 18, 1995 to May 8, 1998

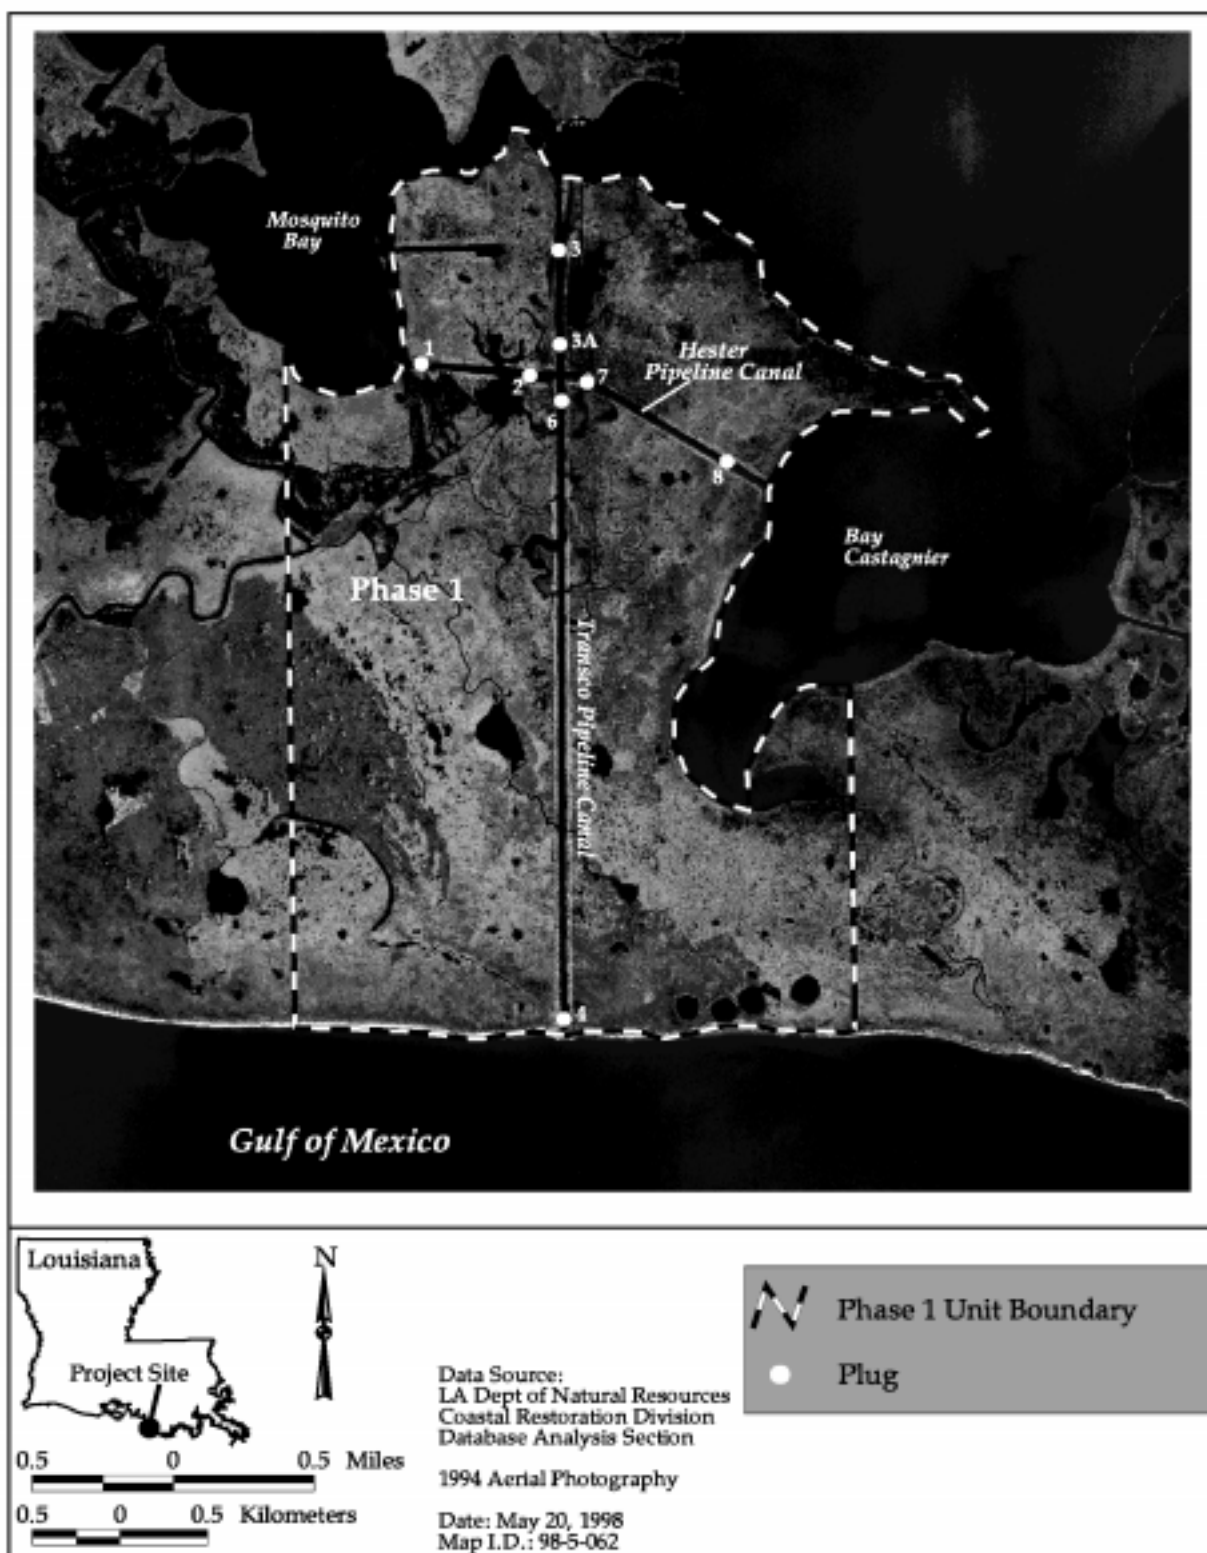
Figure 2. Point au Fer Island Hydrologic Restoration (TE-22) project map of Phase I area showing placement of plugs.

To document the widening of canals, bankline markers were placed along the Hester and Transco pipeline canals in July 1995. Three sets of markers were placed on each side of the canals behind plugs 1, 3, 6, and 8 (figure 2). Pre-construction bankline measurements (baseline data) were determined (table 1, figure 2) within Phase I. Distance was measured between vegetated edges of the canals and the markers. Construction

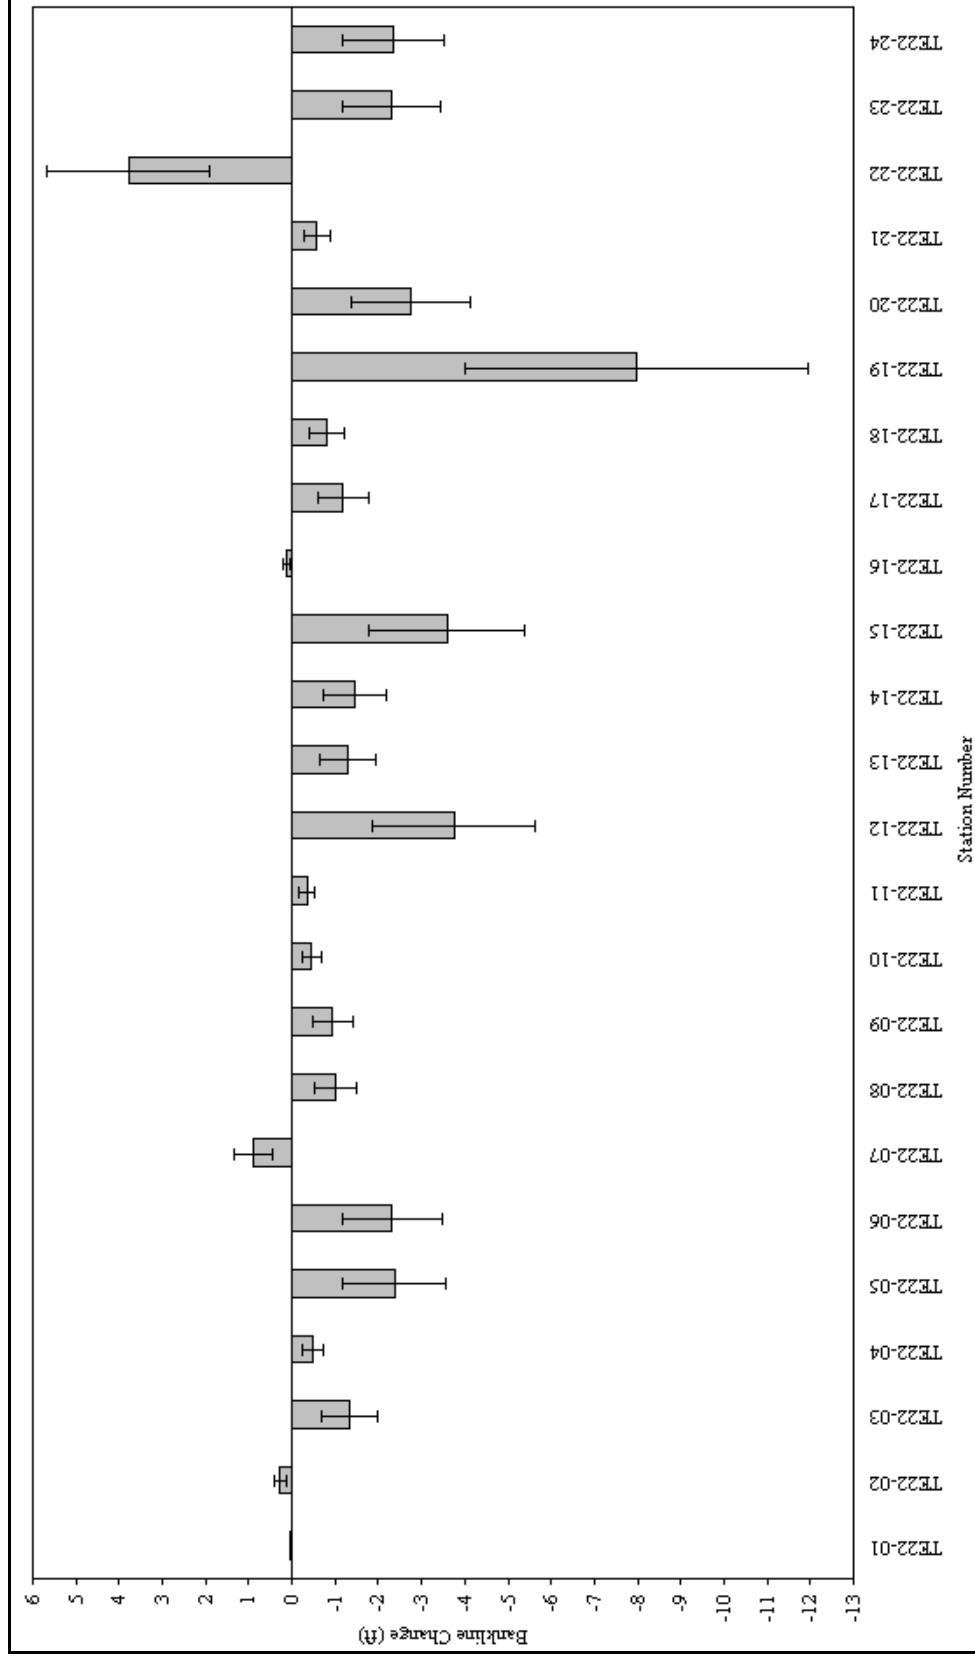
Figure 3. Point Au Fer Island Hydrologic Restoration (TE-22) project bankline change (10/95 - 9/97).

project area. The bankline change was statistically analyzed ($\alpha = 0.05$) to determine differences in bankline movement among plugs and/or differences among the two perpendicular canals. The means were not significantly different ($P = 0.83$) at all four plugs and both canal directions. No plug or canal, regardless of direction/location, appears to be eroding faster than any other, although high variances exist within the data.

The high variances in the phase I data could be a result of the sample size being too small ($n = 24$). Plug 8 had the highest variance of data. This was the first plug to be constructed and wheel wash from the boat was facing inside the project area. This may explain some of the high variability of bankline measurements at this plug.
